December 8, 2023

Ms. Brenda Golden
SAU 95 Windham School District
19 Haverhill Road
Windham, NH 03087

Re: Periodic Indoor Air Quality Testing
Windham Middle School
RPF File 23.0294

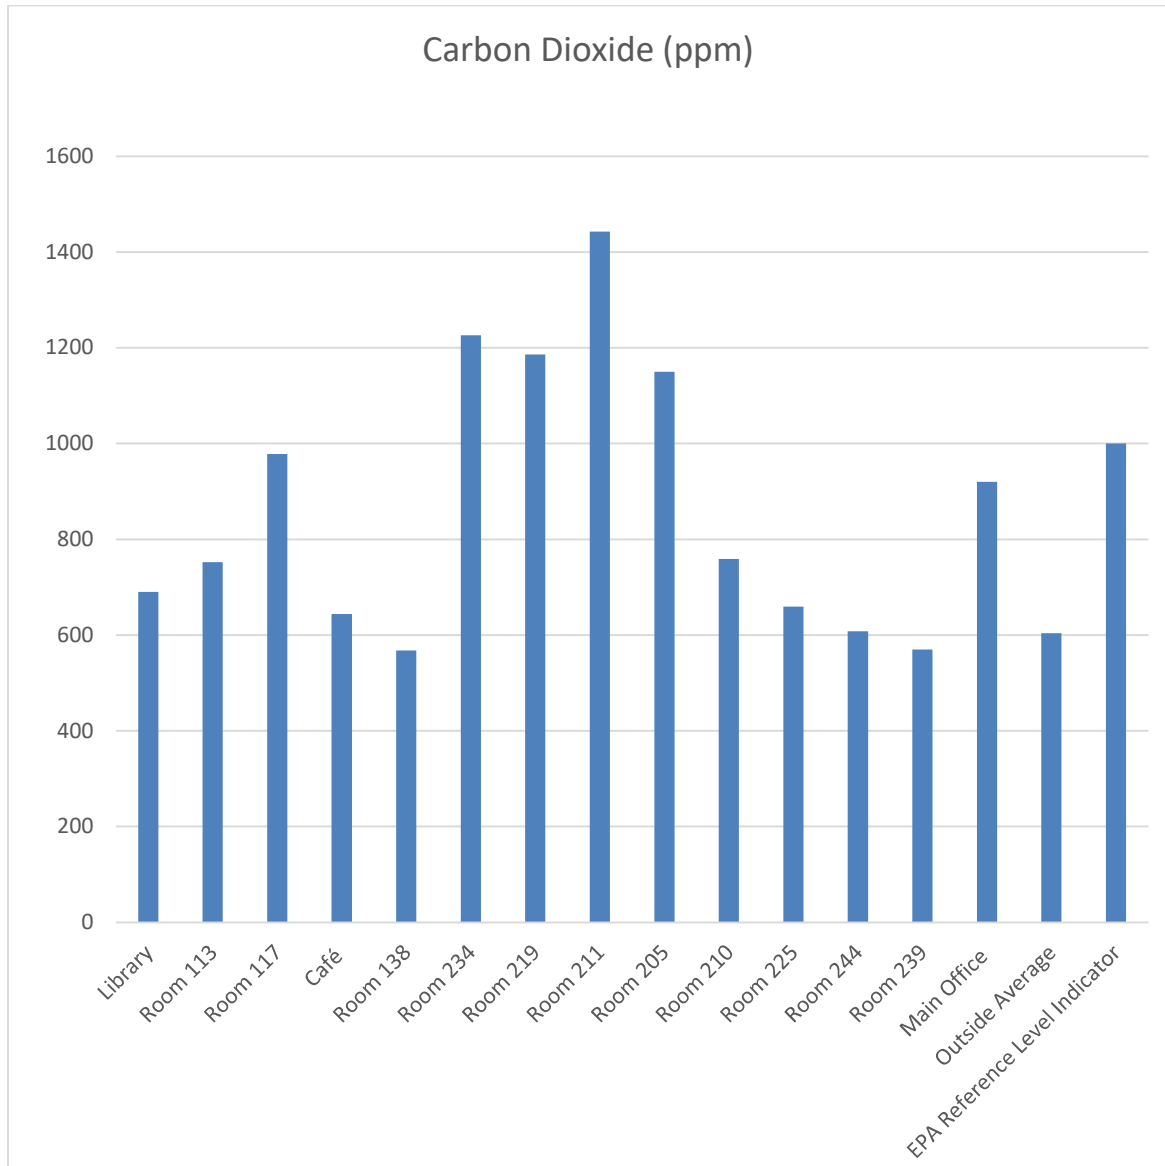
The CO₂ results and testing locations are presented in of Appendix A. CO₂ levels at all indoor locations tested were documented in the range of approximately 568 to 1,443 ppm, which is well below the Occupational Safety and Health Administration Permissible Exposure Limit (OSHA PEL) of 5,000 ppm. These concentration ranges are within or below the generally accepted guideline limit of 800 to 1,000 ppm, except for readings collected in Rooms 234, 219, 211, and 205, which were elevated above the generally accepted guideline.

- There were CO₂ readings in Rooms 205, 211, 219, and 234 were elevated above the generally accepted guideline of 800 to 1,000 ppm, but all readings collected within the building were below the OSHA PEL of 5,000 ppm. As indicated above, investigating the feasibility of increasing the tempered FOA to the office area would help to dilute the concentrations of CO₂ in the air.

According to the USEPA, pollutant or contaminant source control is usually the most effective way to improve indoor air quality. If source control efforts are not sufficient, increasing the amount of outdoor air coming indoors may prove to be helpful.

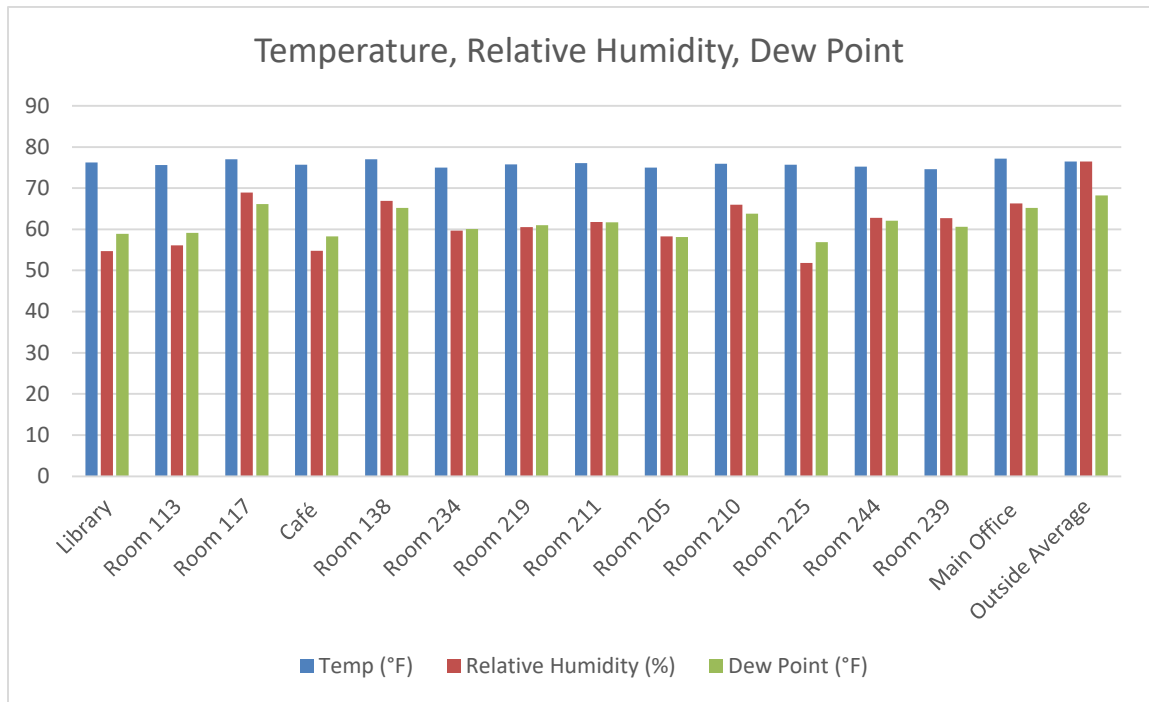
Temperature will affect the occupant’s perception of IAQ based on employee comfort levels, effect of drafts or airflow, and humidity levels in a building. In most cases, simple adjustments to thermostats and direction of airflow from registers can improve perceived IAQ. As a reference, the temperatures recommended by ASHRAE for general office space ranges from approximately 68° to 75° Fahrenheit in the winter, and from approximately 75° to 80° Fahrenheit in the summer. Temperature readings at all indoor locations tested were documented in the range of 74.6° to 77.2° Fahrenheit.

The amount of water vapor that can be contained in the air varies by the temperature and pressure of the air. The ratio of water vapor in the air to the maximum amount of water vapor the air can hold at a given temperature is expressed as relative humidity (RH). The recommended RH comfort range is 35% to 55%. In general, for buildings, the presence of excessive moisture can lead to mold growth and other biological contaminants. Low RH, common for buildings in New England during colder months, may contribute to irritated mucous membranes, dry eyes, and sinus discomfort while high relative humidity, common in summer, may cause discomfort, as it hinders the body’s use of perspiration as a cooling mechanism. RH levels at most of the indoor locations tested during this survey were elevated above the generally accepted comfort range.

become wet. Dew point measurements on the day of testing ranged from 56.9° to 66.1° Fahrenheit. Based on these results, the interior temperature readings were all above the Dew Point readings. The results and testing locations are presented in Appendix A.

- Overall, the readings collected inside the building for each IAQ parameter tested during this survey were either within or below their respective standard and/or comfort range, except for CO₂ and RH. Most of the RH levels in the building were elevated above the generally accepted comfort range of 35 to 55%, which is not uncommon during warmer months in New England. On the day of the testing, the RH levels outside of the building were also elevated above the generally accepted comfort range and could have contributed to the elevated RH levels in the building. The RH levels will naturally decrease with the coming colder weather but, in the meantime, dehumidifiers can be used to decrease moisture in the air. However, it should be noted that if not properly cleaned and maintained, these units can become sources of future fungal growth.

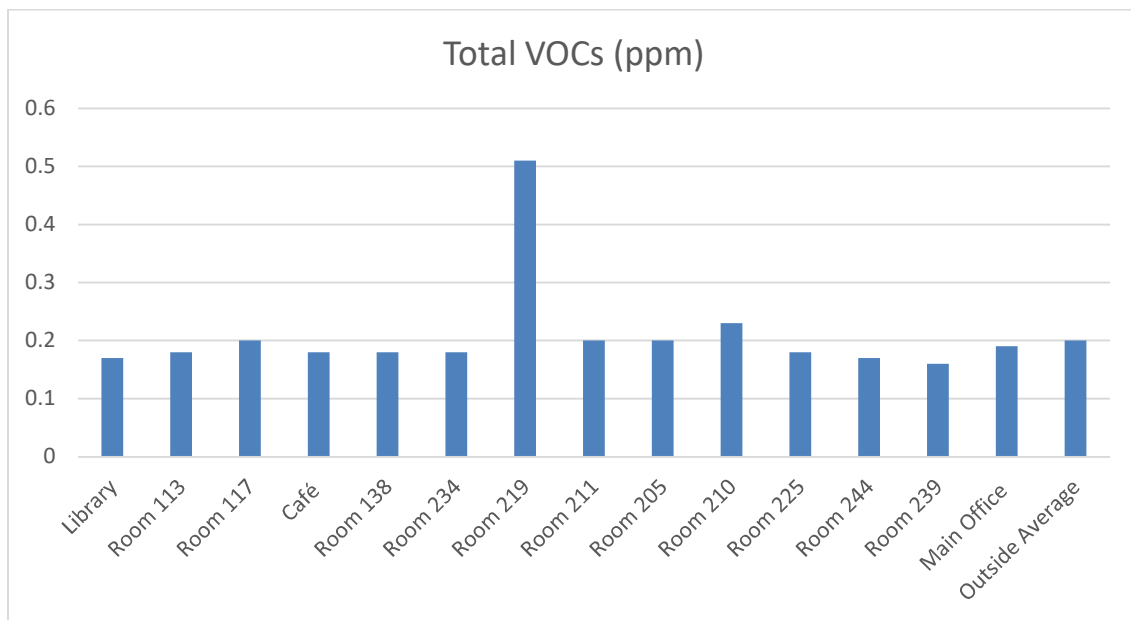
The scope of this survey included screening for total volatile organic compounds (VOCs). During this testing, total VOCs were measured at 0.51 parts per million (ppm) or less for all locations. The outside air was measured at an average of 0.20 ppm. These results are summarized below and presented in Appendix A.

- Most of the TVOC readings were within the “normal indoor air range depicted above. However, there was a reading collected in Room 219 that was elevated above the “normal indoor air” range. Various compounds, such as cleaning agents, chemicals, paint, air fresheners, hand sanitizer, etc., can produce TVOCs and could have contributed to the elevated TVOC readings present in the above listed areas. As indicated above, investigating the feasibility of increasing the tempered FOA to these areas would help to dilute the concentrations of TVOCs in the air.

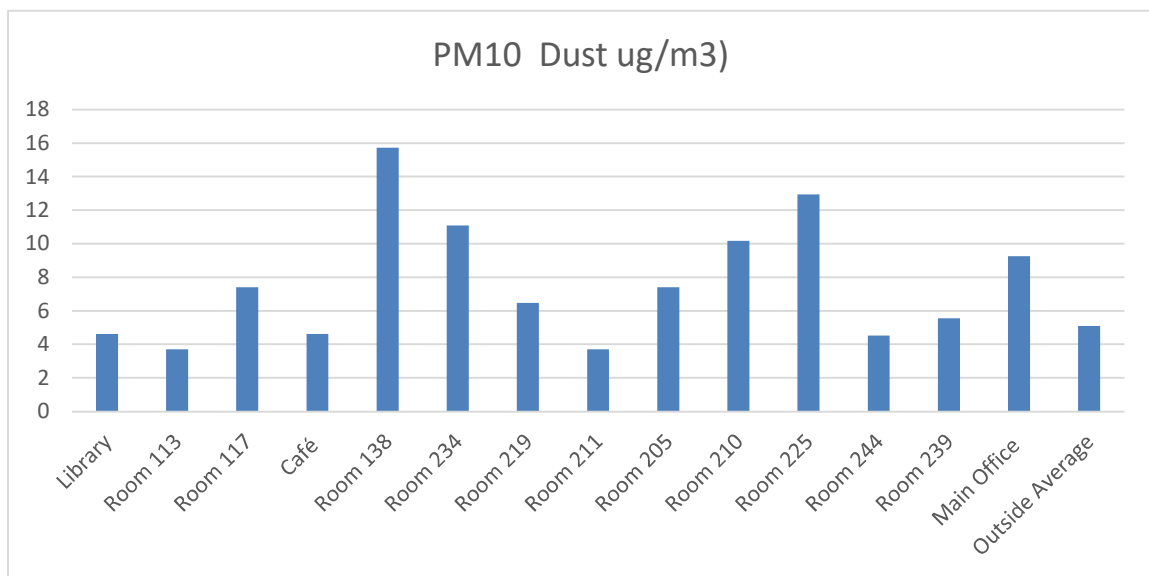
Direct reading determinations for PM₁₀ at all indoor locations tested were in the range of approximately 3.7 to 15.72 micrograms per cubic meter of air ($\mu\text{g}/\text{m}^3$). The results at some of the interior locations tested were elevated above the values found outside, which was approximately 5.1 $\mu\text{g}/\text{m}^3$. The US EPA does have a National Ambient Air Quality Standard at 150 $\mu\text{g}/\text{m}^3$ which was exceeded during the testing. The World Health Organization (WHO) also has set a standard of 50 $\mu\text{g}/\text{m}^3$ as a 24-hour average and 25 $\mu\text{g}/\text{m}^3$ as an annual average exposure. These results and testing locations are presented in Appendix A.

These results indicate that the HVAC filters are not reducing the overall particle loading inside the building when compared to the outside air. For a building that implements the use of an HVAC system, it is typical to see a 25% to 35% reduction in total particulates inside a building compared to the outside concentration of particulates while the HVAC units are operational. The feasibility of upgrading the HVAC systems' filter efficiency rating could be investigated if complaints were to increase at this building. The American Society of Heating, Refrigeration, and Air Conditioning Engineers (ASHRAE) has recommended filter minimum efficiency reporting value (MERV) of not less than six (6) for filters in HVAC systems supplying air to occupied office space (ASHRAE Standard 62.1-2004-5.9). Follow the manufacturer's recommendations for a filter change out schedule.

- There were PM₁₀ readings within the building that were elevated above the outside readings, but all readings collected within the building were well below the NAAQS of 150 ug/m³.

Other steps to reduce indoor PM₁₀ concentrations include proper ventilation, away from HVAC intakes, of combustion appliances to the outdoors, proper exhaust vents in cooking areas, proper use of wood stoves, and professional maintenance of heating systems.

- Heating systems should be inspected on an annual basis or more frequently as required by the manufacturer. RPF recommends implementing and maintaining a preventative maintenance and inspection program for the HVAC system including air filter change-out schedule on a quarterly basis and inspecting for the proper seating of air filters within the filter housing of each air handling unit in order to help eliminate potential air bypass of air filters.
