January 26, 2024

Re: Indoor Air Quality Testing
SAU 95 – Windham Middle School
RPF File 23.0294

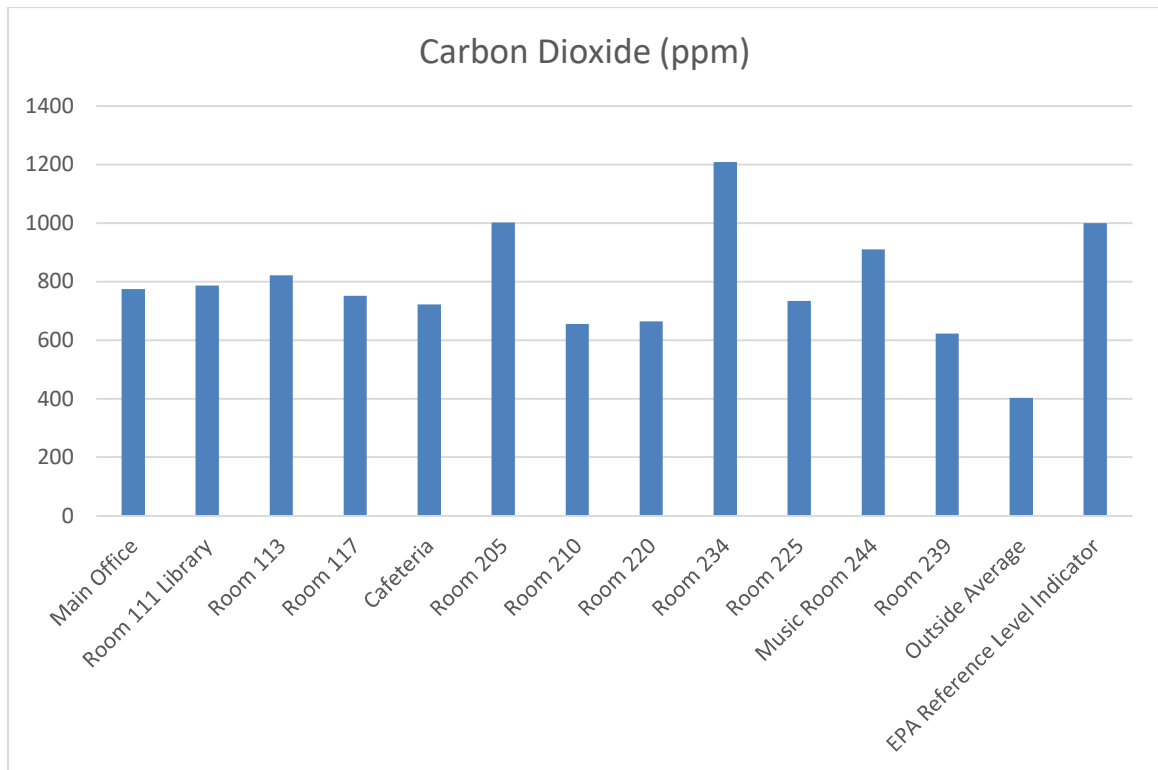
The CO₂ results and testing locations are presented in Appendix A. CO₂ levels at all indoor locations tested were documented in the range of approximately 623 to 1,209 ppm, which is well below the Occupational Safety and Health Administration Permissible Exposure Limit (OSHA PEL) of 5,000 ppm. Most of these concentration ranges are within or below the generally accepted guideline limit of 800 to 1,000 ppm, except for readings collected in Rooms 205 and 234, which were elevated above the generally accepted guideline.

- There were CO₂ readings in Rooms 205 and 234 that were elevated above the generally accepted guideline of 800 to 1,000 ppm, but all readings collected within the building were below the OSHA PEL of 5,000 ppm. As indicated above, investigating the feasibility of increasing the tempered FOA to the office area would help to dilute the concentrations of CO₂ in the air.

The American Society of Heating, Refrigerating and Air Conditioning Engineers (ASHRAE) recommends a guideline in their Standard 62-2001 for Ventilation for Acceptable Indoor Air Quality for a maximum of 700 ppm CO₂ above outside air concentrations as a value under which employee complaints are minimized. On the day of this testing, the outdoor ambient concentration of CO₂ was recorded an outside average of 403 ppm with a corresponding value of 1,103 ppm, for a maximum CO₂ for perceived acceptable air quality. The ASHRAE standard also calls for a minimum of 20 cubic feet of outside air (FOA) per minute per occupant be introduced into office spaces, and if applicable, 15 cfm per occupant of classrooms, to maintain dilution of contaminants and perceived indoor air quality.

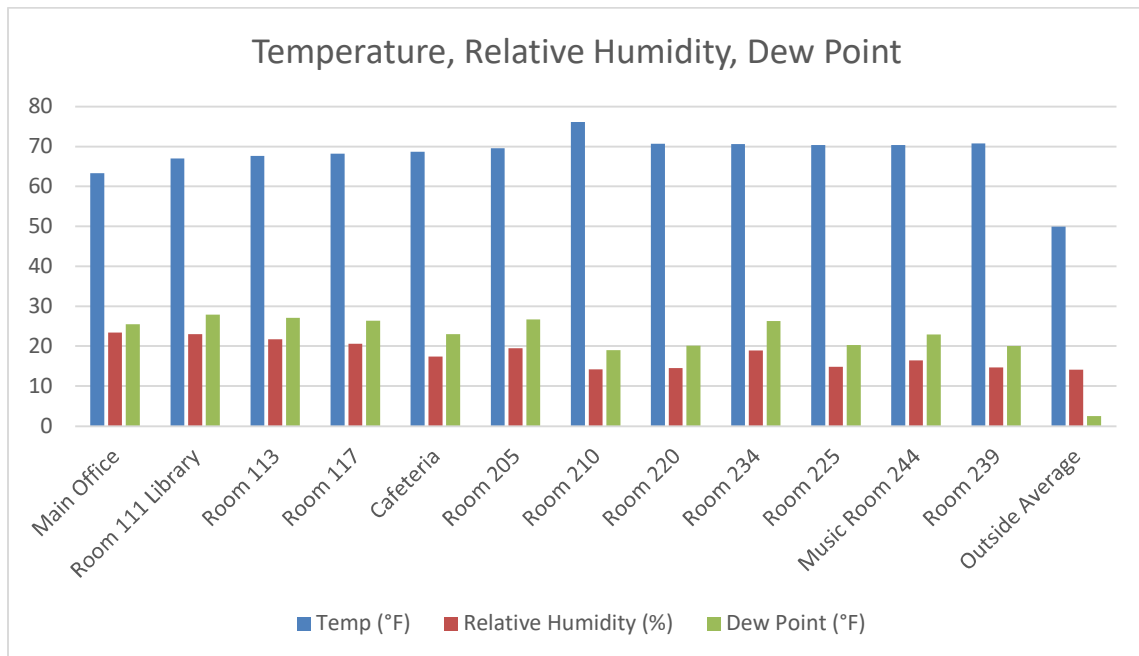
Temperature will affect the occupant's perception of IAQ based on employee comfort levels, effect of drafts or airflow, and humidity levels in a building. In most cases, simple adjustments to thermostats and direction of airflow from registers can improve perceived IAQ. As a reference, the temperatures recommended by ASHRAE for general office space ranges from approximately 68° to 75° Fahrenheit in the winter, and from approximately 75° to 80° Fahrenheit in the summer. Temperature readings at all indoor locations tested were documented in the range of 63.3° to 76.1° Fahrenheit.

The amount of water vapor that can be contained in the air varies by the temperature and pressure of the air. The ratio of water vapor in the air to the maximum amount of water vapor the air can hold at a given temperature is expressed as relative humidity (RH). The recommended RH comfort range is 35% to 55%. In general, for buildings, the presence of excessive moisture can lead to mold growth and other biological contaminants. Low RH, common for buildings in New England during colder months, may contribute to irritated mucous membranes, dry eyes and sinus discomfort while high relative humidity, common in summer, may cause discomfort, as it hinders the body's use of perspiration as a cooling mechanism. RH levels at the indoor locations tested during this survey were below the generally accepted comfort range.

Dew point is related to humidity and is the temperature below which water vapor may start to condense to form water droplets on a surface. If dew forms on interior building materials, the material may become wet, and subsequent fungal growth can occur. For instance, an uninsulated cold-water pipe may form condensation when the temperature of the metal surface is colder than the environmental dew point, and drip onto surfaces causing them to become wet. Dew point measurements on the day of testing ranged from 19° to 27.9° Fahrenheit. Based on these results, the interior temperature readings were all above the Dew Point readings. The results and testing locations are presented in Appendix A.

- Overall, the readings collected inside the building for each IAQ parameter tested during this survey was either within or below their respective standard and/or comfort range, except for CO₂ and RH. The RH levels in the building were below the generally accepted comfort range of 35 to 55%, which is not uncommon during colder months in New England. On the day of the testing, the RH levels outside of the building were also below the generally accepted comfort range and could have contributed to the low RH levels in the building. Low RH levels can contribute to irritated mucous membranes, dry eyes and

sinus discomfort. The RH levels will naturally increase with the coming warmer weather but, in the meantime, humidifiers can be used to alleviate symptoms. However, it should be noted that if not properly cleaned and maintained, these units can become sources of future fungal growth.

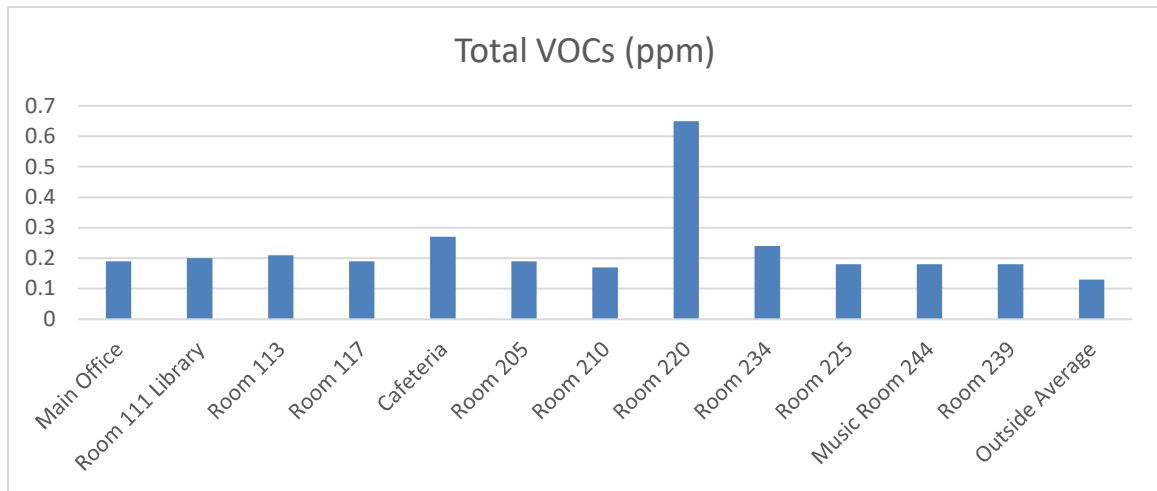
The scope of this survey included screening for total volatile organic compounds (VOCs). During this testing, total VOCs were measured at 0.65 parts per million (ppm) or less for all locations. The outside air was measured and had an average reading of 0.13 ppm. These results are summarized below and presented in Appendix A.

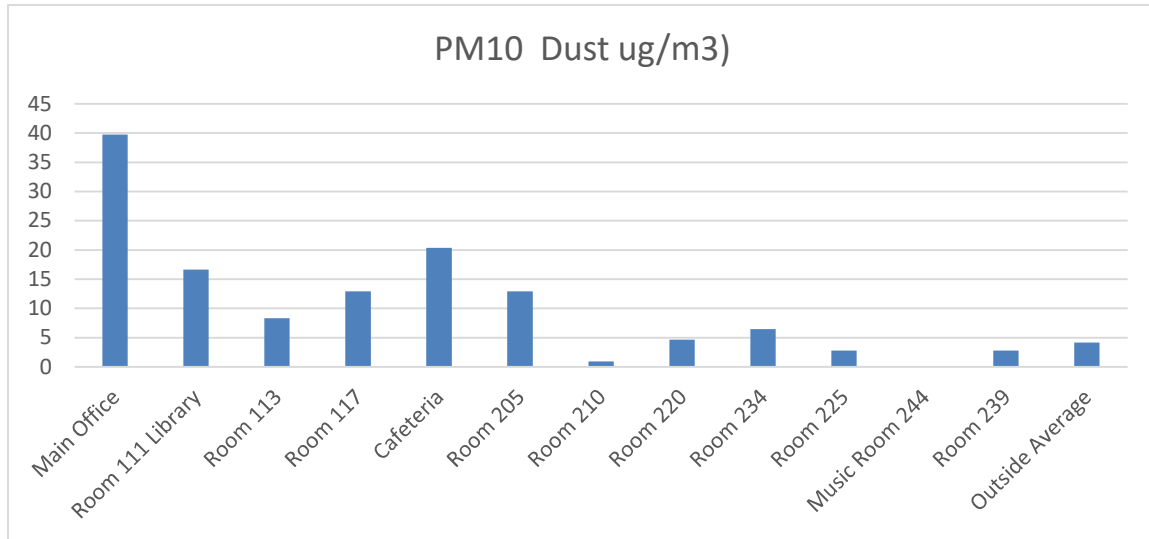
Direct reading determinations for PM₁₀ at all indoor locations tested were in the range of approximately less than 0.01 to 39.76 micrograms per cubic meter of air ($\mu\text{g}/\text{m}^3$). The results at most of the interior locations tested were elevated above the values found outside, which was approximately $4.15 \mu\text{g}/\text{m}^3$. The US EPA does have a National Ambient Air Quality Standard at $150 \mu\text{g}/\text{m}^3$ which was not exceeded during the testing. The World Health Organization (WHO) also has set a standard of $50 \mu\text{g}/\text{m}^3$ as a 24-hour average and $25 \mu\text{g}/\text{m}^3$ as an annual average exposure. These results and testing locations are presented in Appendix A.

These results indicate that the HVAC filters are not reducing the overall particle loading inside the building when compared to the outside air. For a building that implements the use of an HVAC system, it is typical to see a 25% to 35% reduction in total particulates inside a building compared to the outside concentration of particulates while the HVAC units are operational. The feasibility of upgrading the HVAC systems' filter efficiency rating could be investigated if complaints were to increase at this building. The American Society of Heating, Refrigeration, and Air Conditioning Engineers (ASHRAE) has recommended filter minimum efficiency reporting value (MERV) of not less than six (6) for filters in HVAC systems supplying air to occupied office space (ASHRAE Standard 62.1-2004-5.9). Follow the manufacturer's recommendations for a filter change out schedule.

Other steps to reduce indoor PM₁₀ concentrations include proper ventilation, away from HVAC intakes, of combustion appliances to the outdoors, proper exhaust vents in cooking areas, proper use of wood stoves, and professional maintenance of heating systems.
